Inspection Report

Property Address:
123 anystreet
anywhere ny 11111

Bonvo Home Inspection LLC

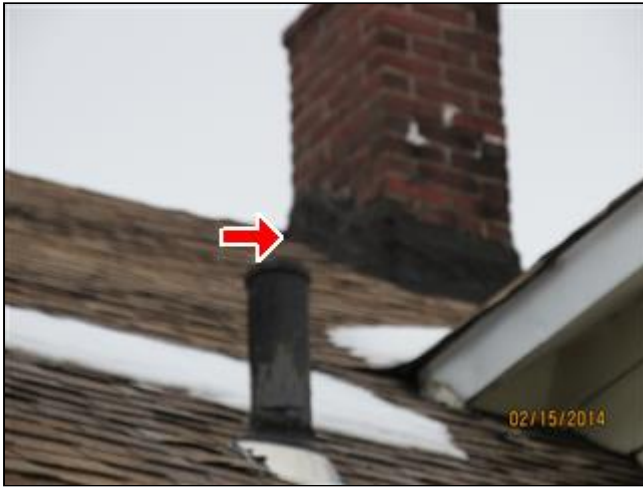
1.1 Picture 1

The chimney is not properly flashed. Roofing tar will eventually crack and leak. Suggest replacement by a qualified roofer with a metal step flashing.

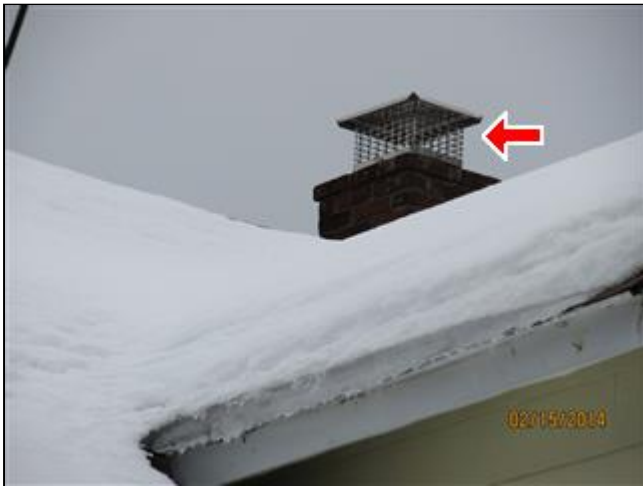
1.2 Picture 1

The chimney crown was not visible from the ground.

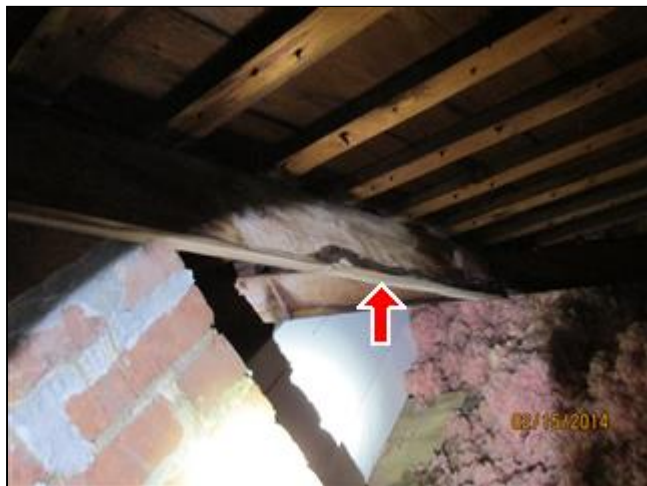
1.5 Picture 1

Water stains on some roof rafters suggest previous water penetration. These stains were not wet at the time of inspection.

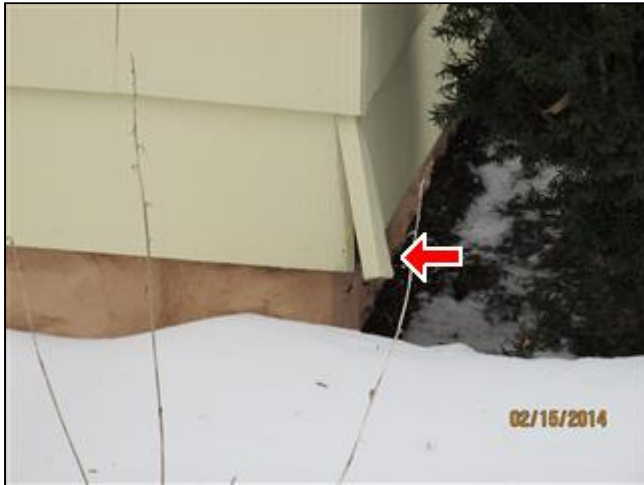
2.0 Picture 1

(1) Several areas of trim and siding had small cracks or gaps. Have areas repaired by a professional contractor to prevent rain or rodent intrusion.

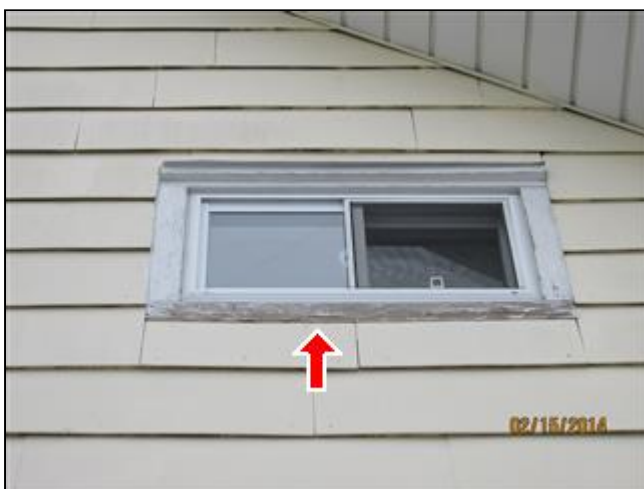
2.0 Picture 5

(2) Wood trim around several windows and doors is worn and needs to be painted. Exterior wood trim left exposed to the elements for extended periods of time will lead to rot and water penetration.

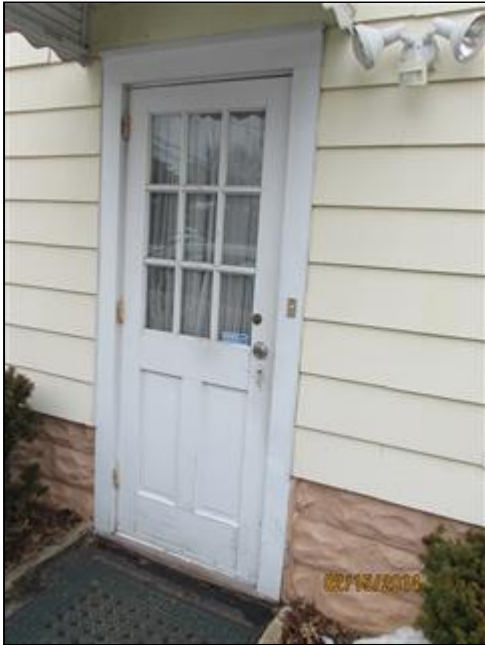
2.1 Picture 1

(1) Exterior doors are wood and single paned glass doors. These doors appear to be over 20 years old and typical wear is visible. All doors were fully functional at the time of inspection. These doors may be drafty and not energy efficient due to their age. replacement may be desired.

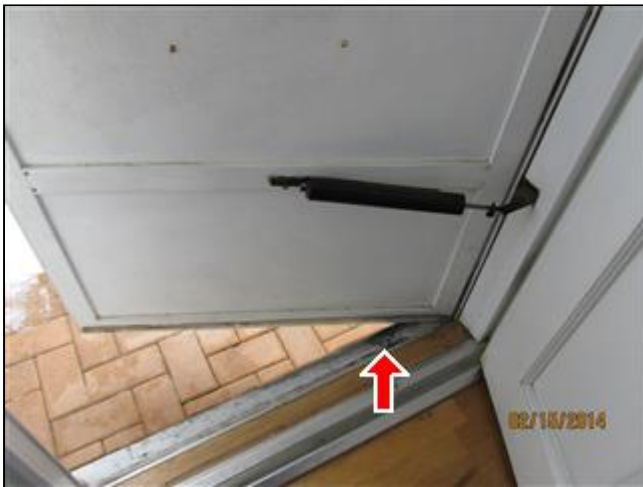
2.1 Picture 3

(2) The front storm door did not close properly on its own. It appears to be rubbing at the sill. Adjustments or repair may be necessary for proper operation.

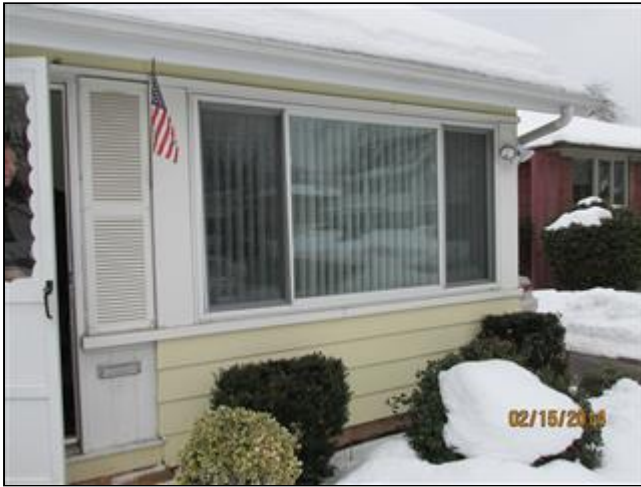
2.2 Picture 1

This house contains original single pane windows, metal replacement windows and vinyl replacement windows. All windows appear to be well maintained for their respective styles and ages. Older single pane windows are not energy efficient. Replacement may be desired.

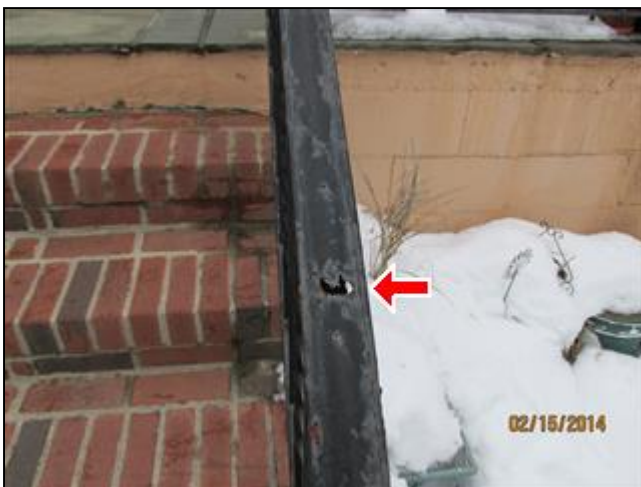
2.3 Picture 1

Rusted and rotted metal railings should be inspected for soundness and sharp edges which create a hazard.

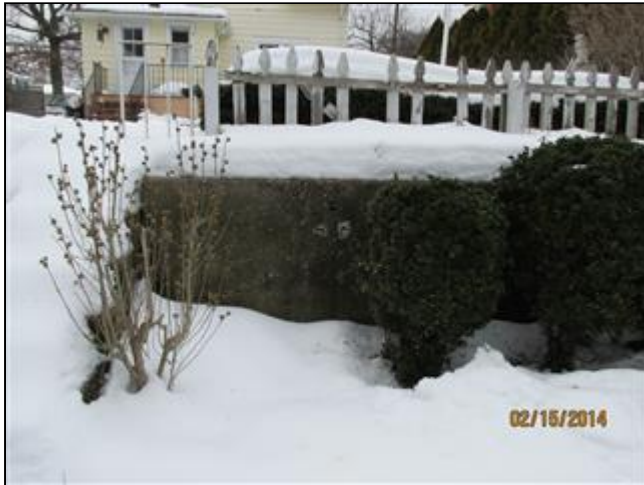
2.4 Picture 1

The rear retaining wall showed some cracks but appeared intact. This wall should be monitored regularly with maintenance performed as needed.

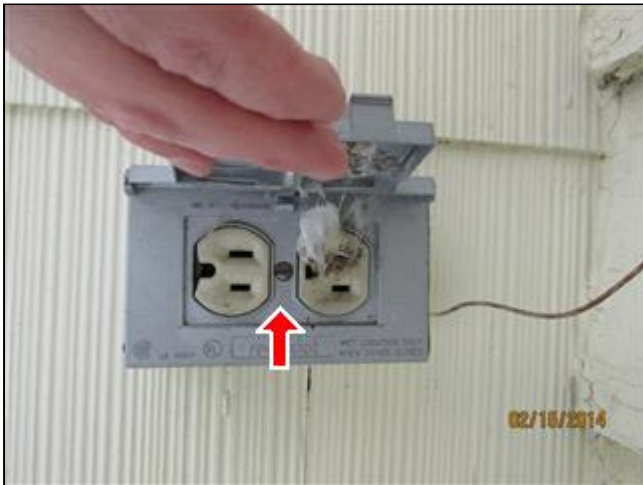
2.7 Picture 1

(1) All outdoor outlets should be GFCI outlets. Replacement by a licensed electrician is recommended.

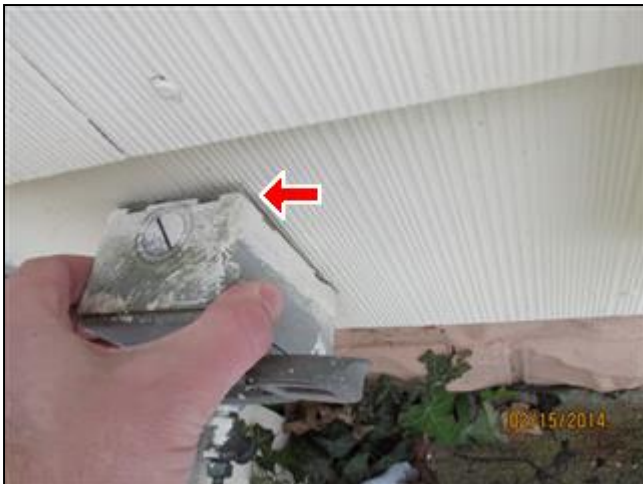
2.7 Picture 3

(2) Some exterior outlet boxes were loose. Recommend inspection with repairs as needed by a licensed electrician.

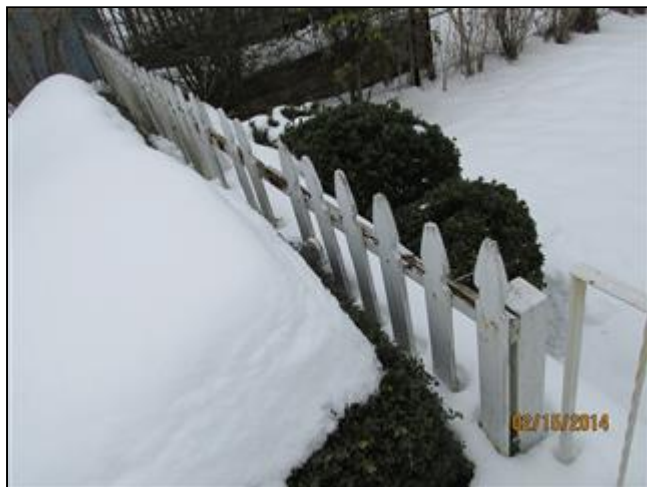
2.8 Picture 1

Fences are not a part of a home inspection. However visual inspection of the fences on the property show signs of wear and deterioration. Replacement will be required in the not to distant future.

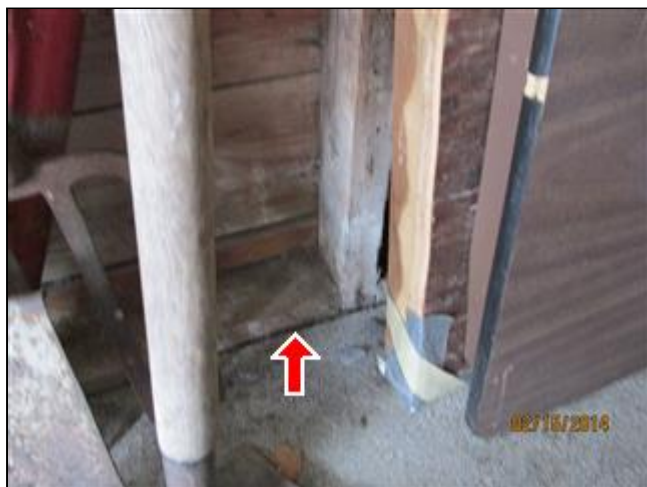
3.1 Picture 1

The sill plate in the garage rests outside the garage floor slab and may be in direct contact with the soil. This should be monitored for rot and wood destroying insect damage. No damage was visible during this inspection, however the presence of stored items prevented close inspection of the entire garage.

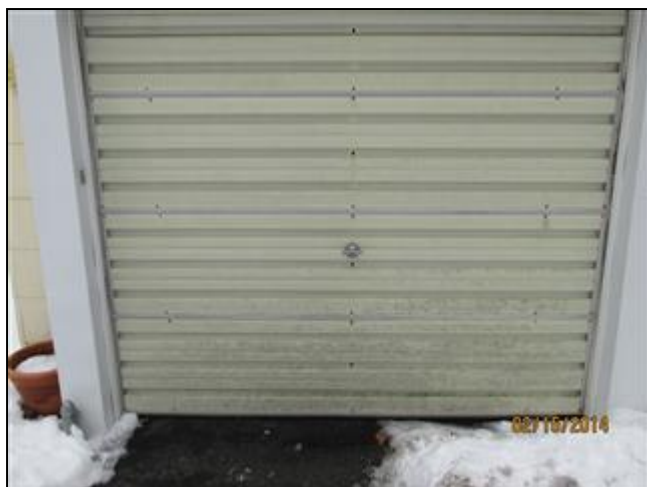
3.3 Picture 1

The garage door shows signs of stress cracks. It appears to be old and may need to be replaced in the not to distant future.

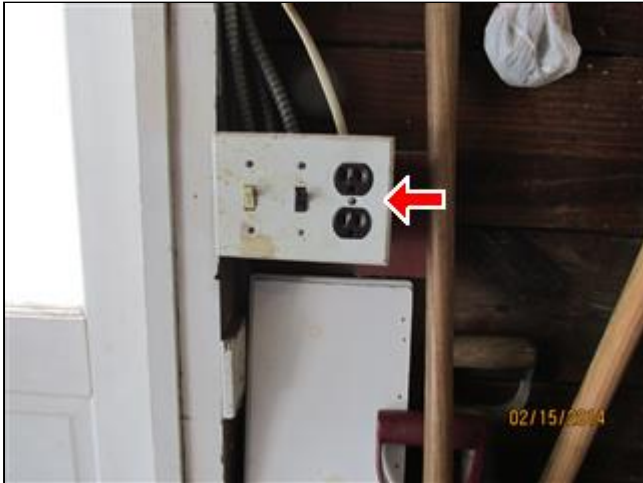
3.5 Picture 1

Electrical outlets in a garage should be GFCI outlets. Recommend upgrade to GFCI outlets by a licensed electrician.

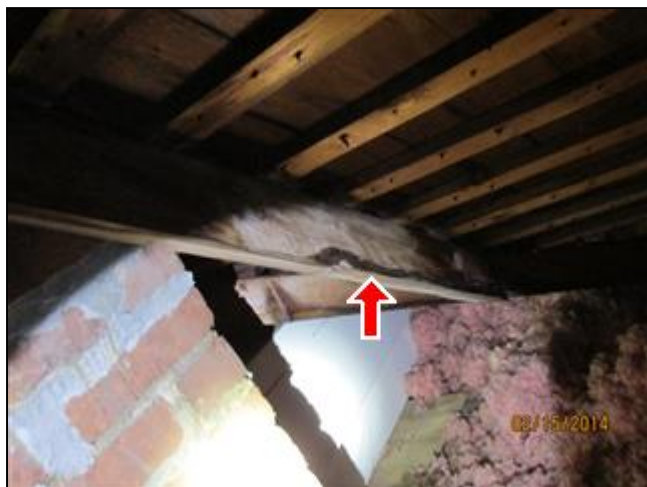
4.1 Picture 1

Several roof rafters had stains. The stains were dry at the time of inspection. This is evidence of past moisture problems.

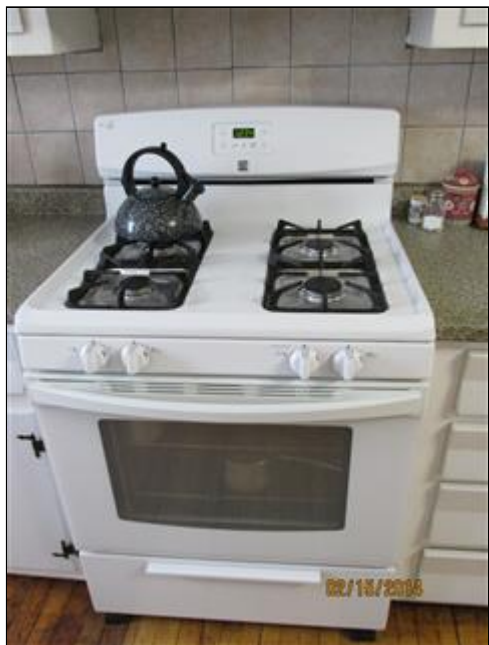
5.10 Picture 1

Gas stove and oven was functional at the time of inspection. All burners and the oven lit with the normal range controls.

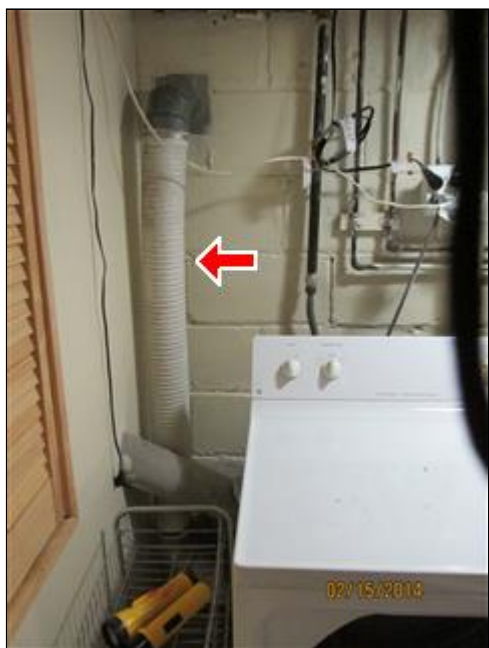
5.12 Picture 1

Clothes dryer vent should be rigid metal to avoid lint build up and the possibility of fire. Recommend replacement.

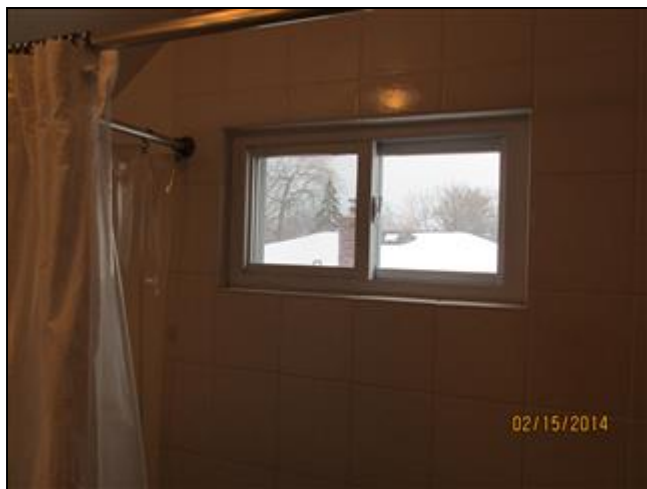
6.8 Picture 1

One of the panes in the window is cracked. This is a double paned window. Only the interior pane is cracked. Energy efficiency has been compromised and condensation can now accumulate inside the window.

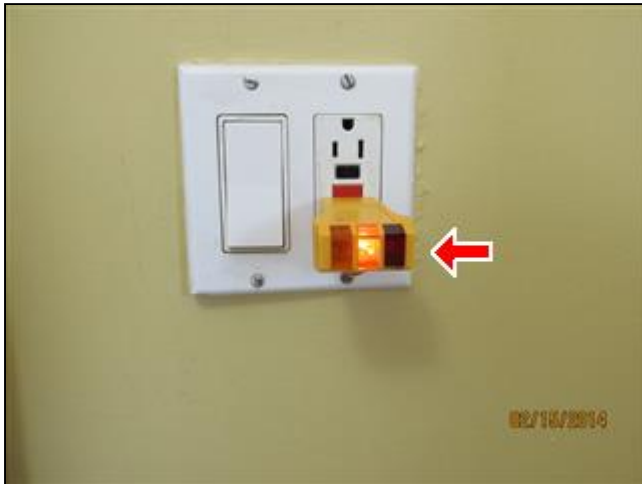
7.7 Picture 1

The GFCI outlet at the downstairs bath is a non-grounded outlet which is currently acceptable, however, it should be labeled a non-grounded GFCI and it is not as safe as a grounded GFCI.

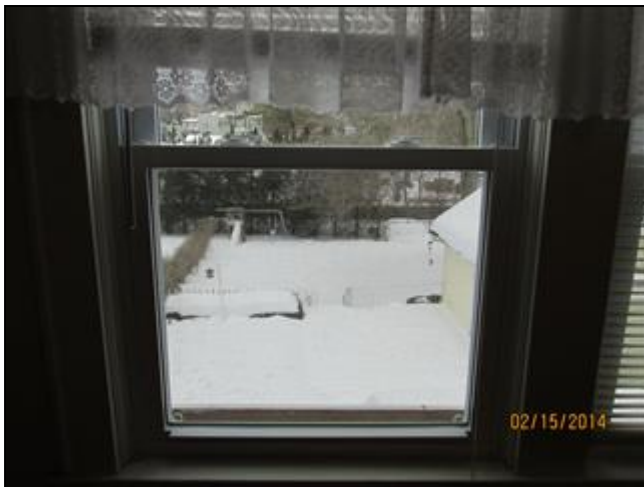
8.5 Picture 1

A random sampling of windows were tested. Windows and locks were functional at the time of inspection. Several of the downstairs windows were older metal replacement windows. These may not last as long as the newer vinyl replacement windows. Some old single pane wood windows were also present in the house. Replacement of these windows may be desired for energy efficiency.

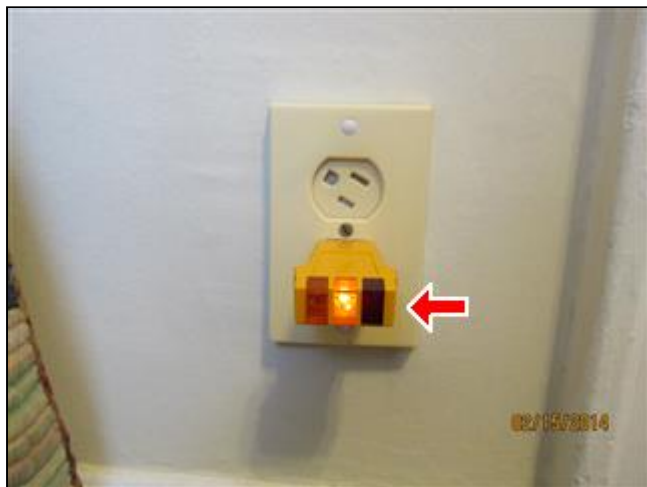
8.6 Picture 1

(1) A random sampling of outlets were tested. Some outlets were found to have an open ground. Recommend repair/replacement by a licensed electrician.

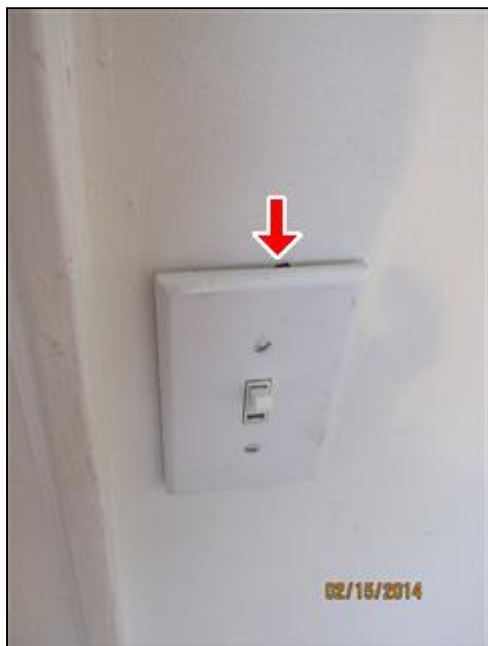
8.6 Picture 2

(2) A random sample of light switches were tested. Some switch plates or boxes were loose. Recommend repair by a licensed electrician as needed.

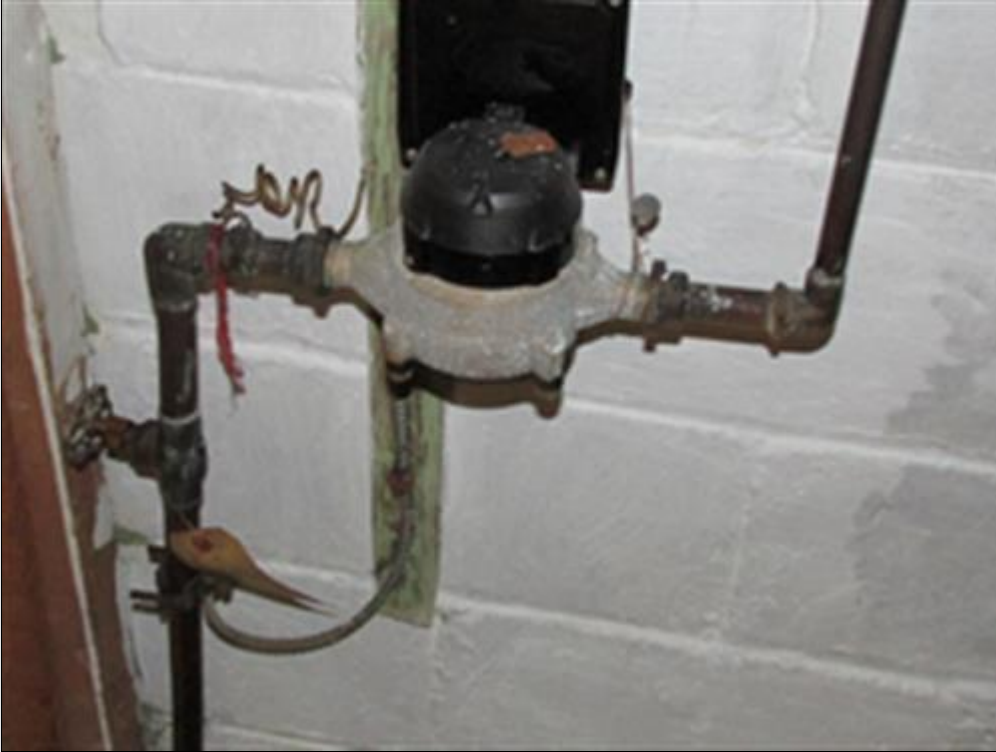
10.1 Picture 1

The ground wire should "jump" the water meter. This means the main electrical ground wire should be connected to the water main on both sides of the water meter. Recommend evaluation and repair by licensed electrician.

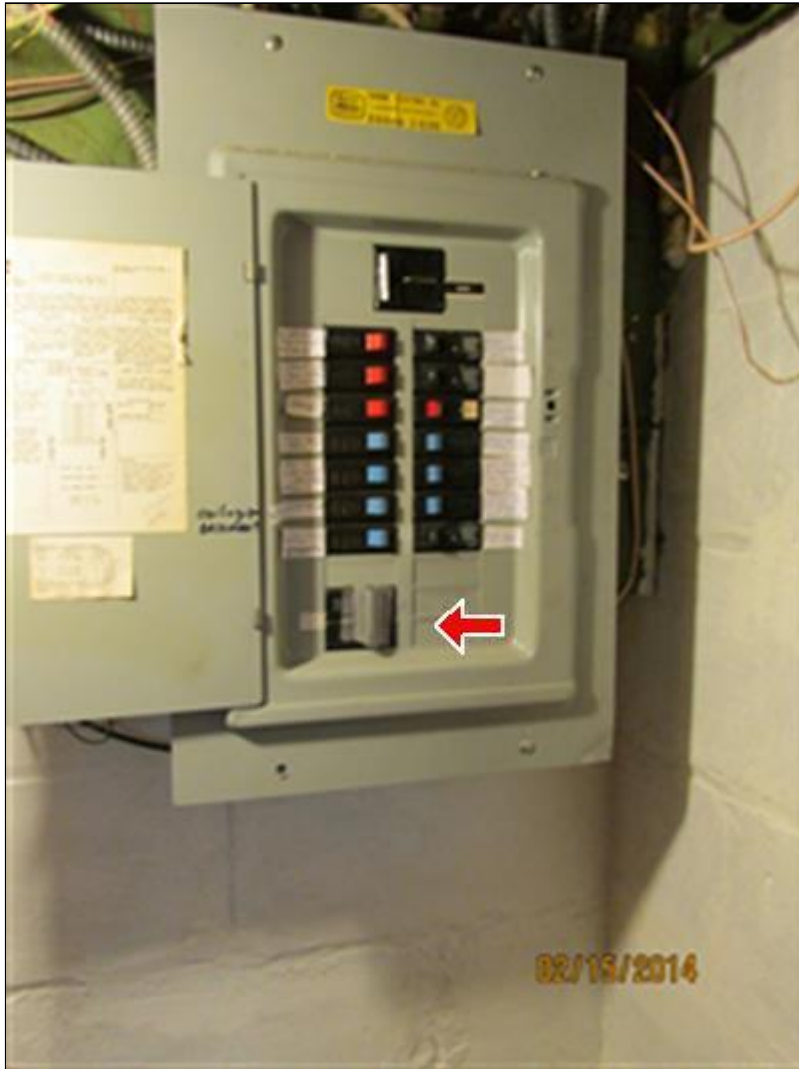
10.2 Picture 1

Double breaker is covered with electrical tape. Suggest evaluation by a licensed electrician with repairs as needed.

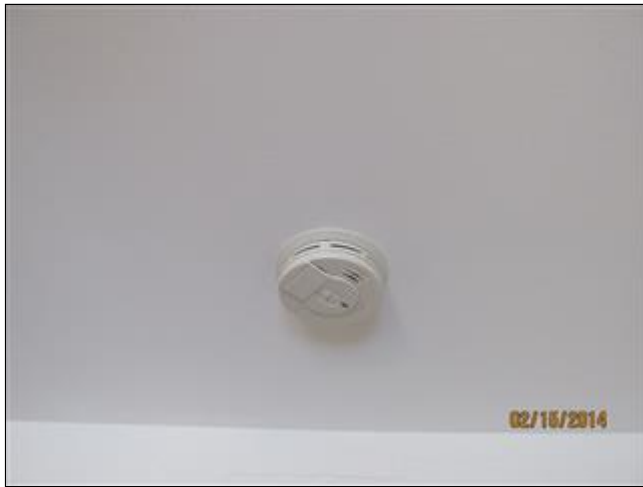
10.7 Picture 1

It is recommended that smoke and carbon monoxide detectors be located throughout the house as recommended by state and local building codes.

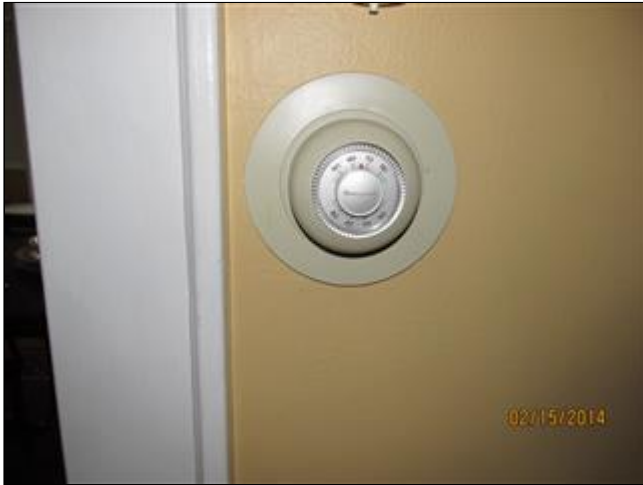
11.8 Picture 1

Thermostat is located in the living room. Recommend upgrading to a programable thermostat for greater energy efficiency.

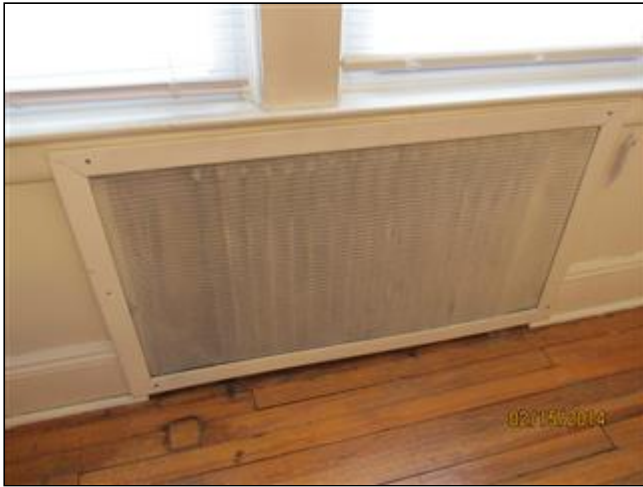
11.9 Picture 1

Many radiators were recessed or covered at the time of inspection, limiting the ability to visually inspect the radiators. Exposed radiators were in good condition. Heat was radiating from all radiators.

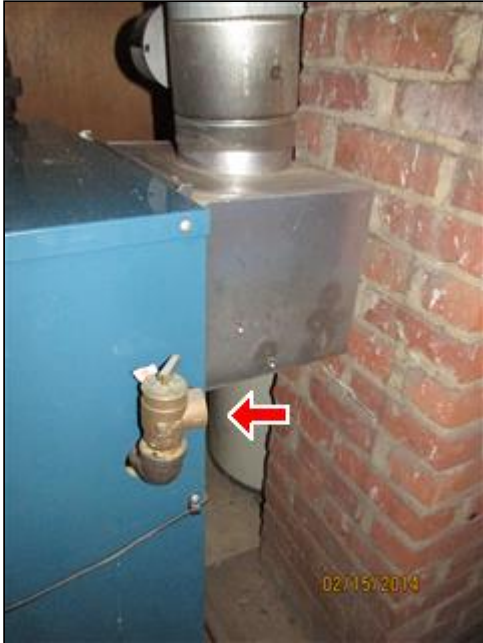
11.10 Picture 1

The Pressure relief valve should be piped to within 6 inches of the ground. Recommend repairs by a licensed plumber.

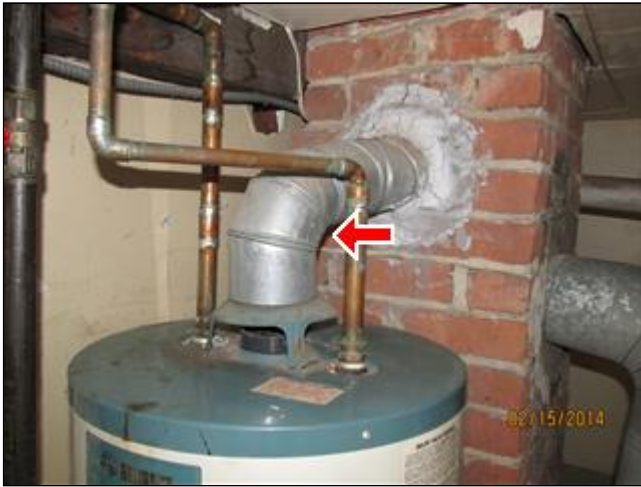
12.2 Picture 1

(1) The vent for the hot water heater is only 3". The proper size vent for a hot water heater is 4". Recommend evaluation by a licensed plumber with repairs/replacement at needed.

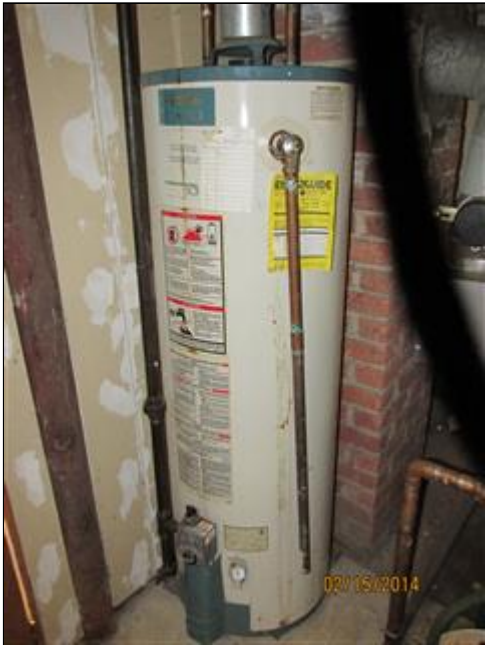
12.2 Picture 2

(2) Although this water heater is functional and in overall good condition it has exceeded its design life. The water heater is approximately 23 years old and has a design life of only 7-10 years. Typically when water heaters fail they begin to leak from the bottom. Replacement by a licensed plumber is recommended due to its age.

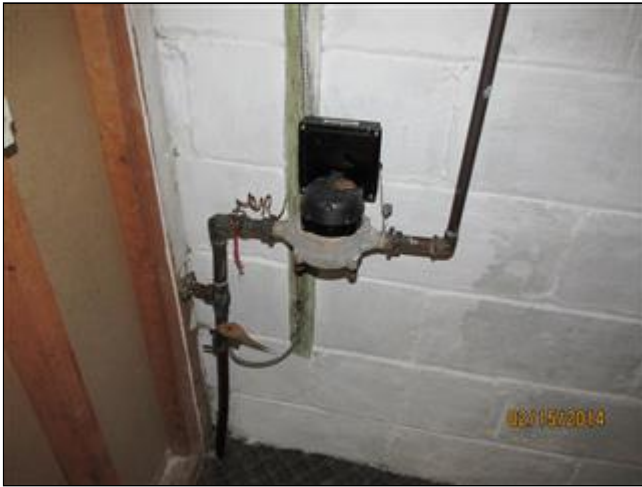
12.3 Picture 1

Please note: main water shut off valves are subject to failures due to their infrequent use. The main water shut off valve is not operated or tested for that reason.

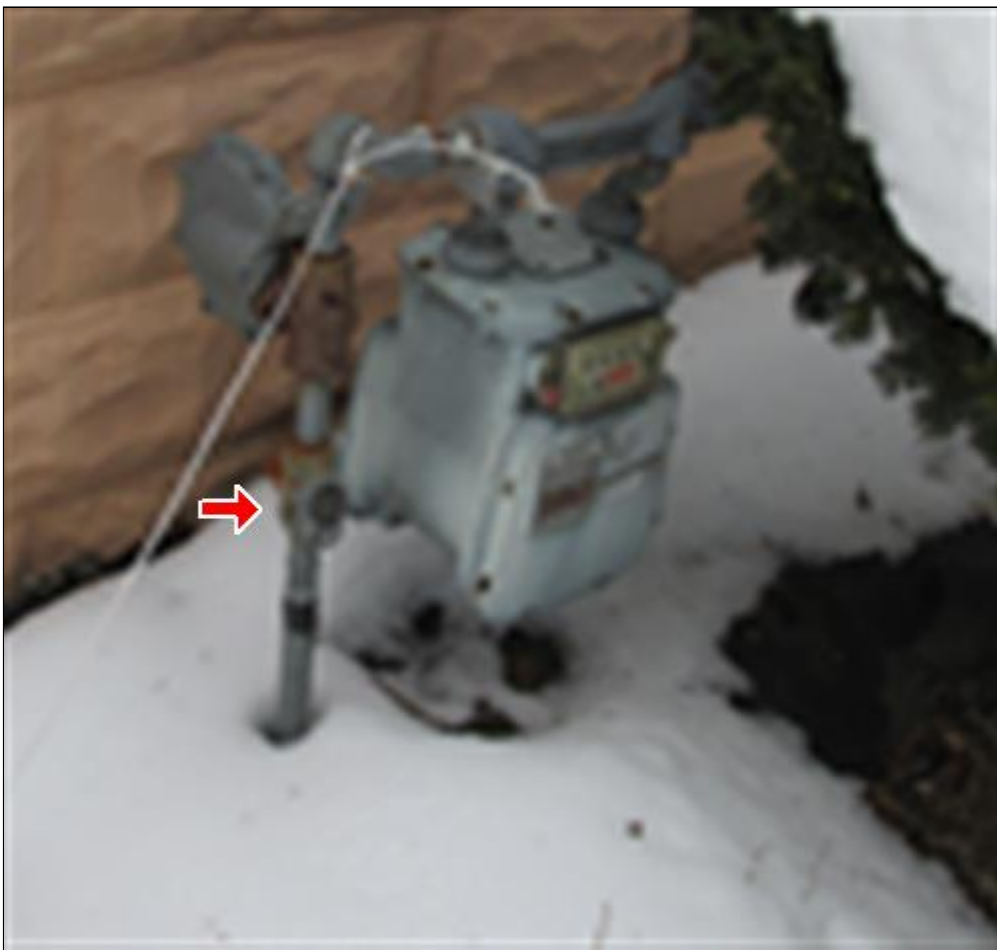
12.5 Picture 1

The gas meter and main shutoff are located on the left side of the house near the front of the house.
